## Remedial Branch update 9-21-17 for the 9/22/17 Report

San Jacinto: The RPs continue cap repairs and maintenance activities. All work is being conducted in accordance with the approved work plan and under EPA oversight. Mini-pontoon boat used in shallow water areas (Figures 1, 3, and 4), while the larger boat and pontoon are used for deep water work (Figure 5).

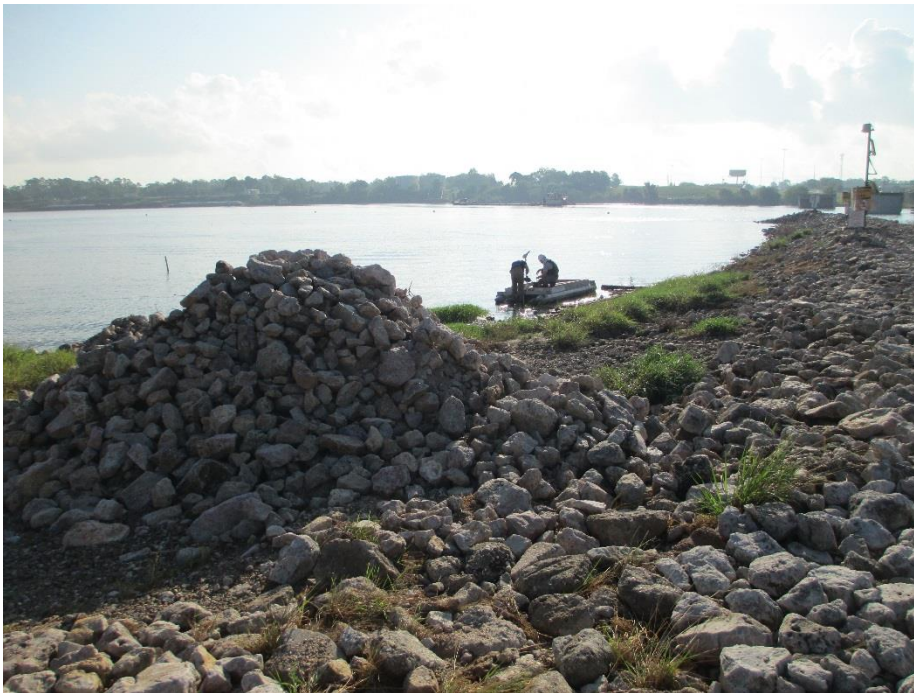
Figure 1: San Jacinto -moving to North Cell

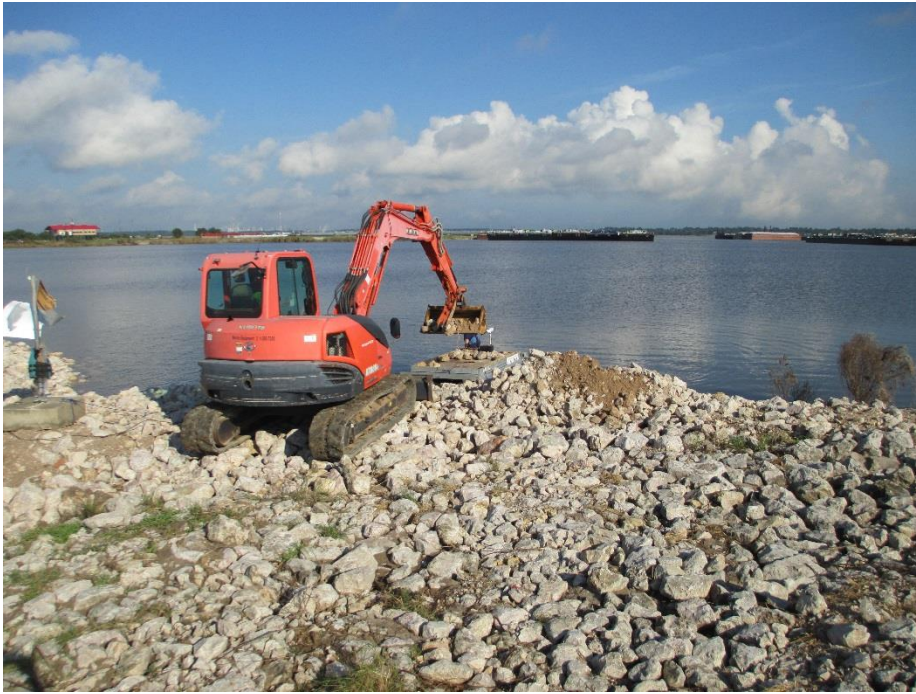
*Figure 2: San Jacinto - loading rock into mini-pontoon.*

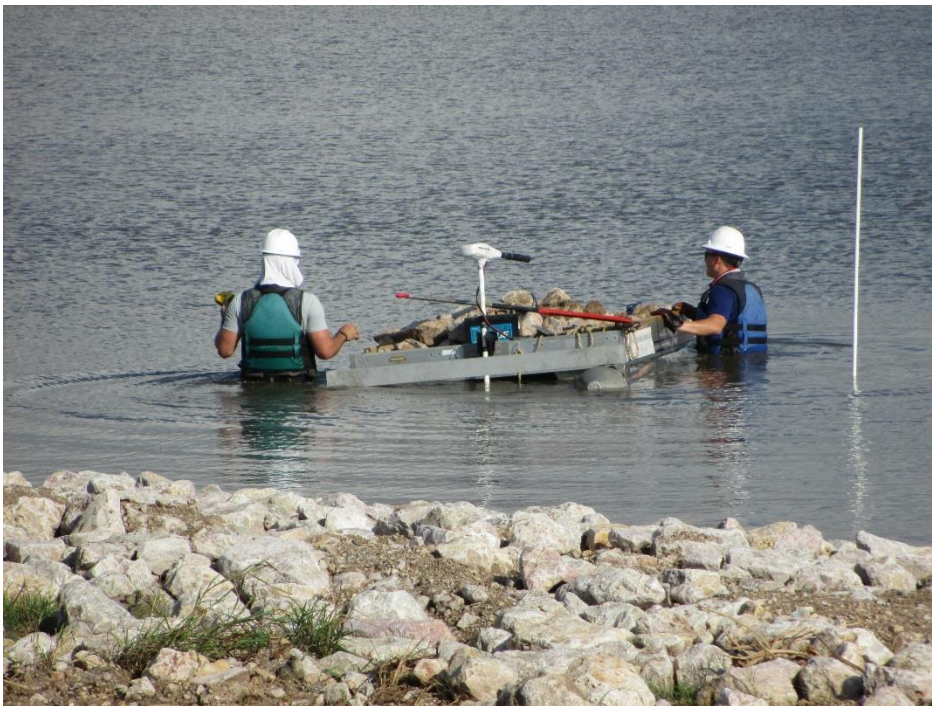
*Figure 3: San Jacinto - placing rock in pre-designated GPS areas.*

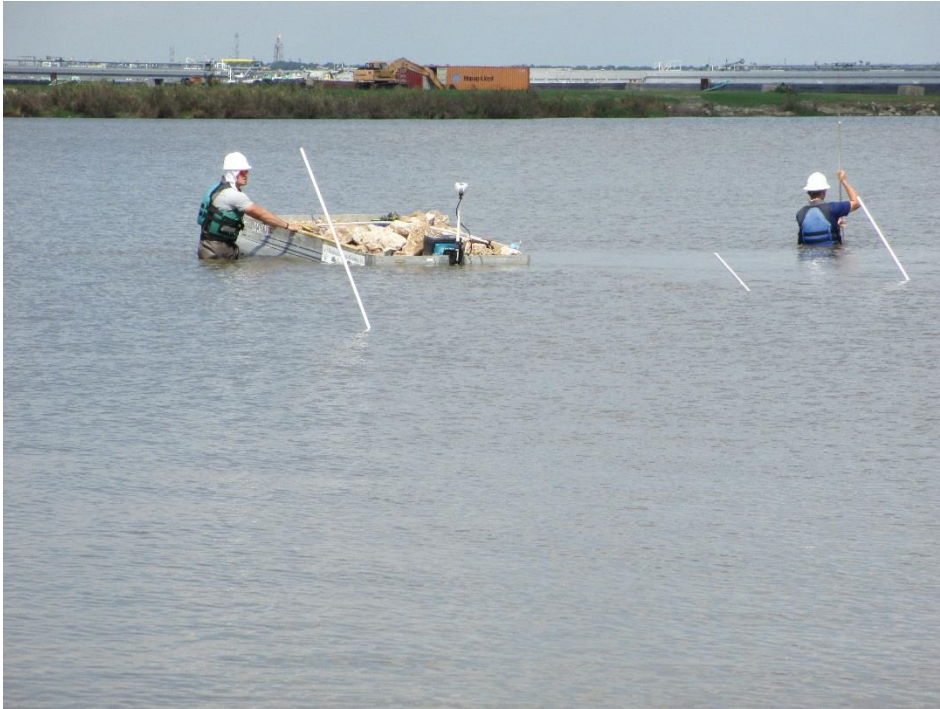
*Figure 4: San Jacinto-white markers define rock placement areas.*

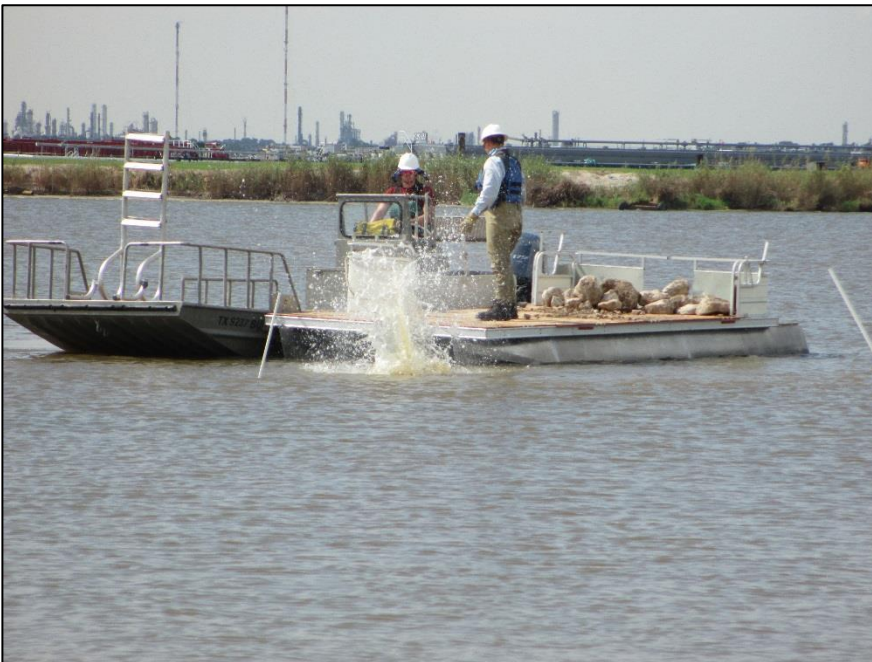
*Figure 5: Rock placement in deeper water.*
